Technical Bulletin 1012

iSED®/iSED ELITE Software Upgrade to v2.1.0

Products Impacted:	Product	Part Number
	iSED (SN >05000)	112-00101
	iSED ELITE	112-00222

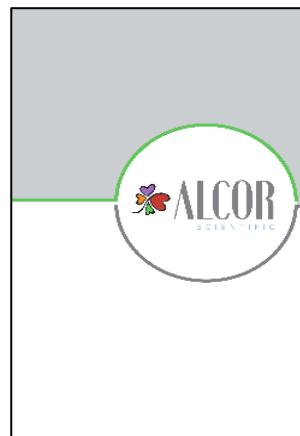
Figure 3

7. Depending on the current software already on the device, iSED will reboot itself one or more times. The device will remain on the ALCOR Scientific “splash” screen (Figure 3) while installing the software, then advance to the Home Screen upon completion.
