# iSED® Automated Erythrocyte Sedimentation Rate Analyzer

## Syringe Probe Tube Cleaning Procedure, 112-28-014 Rev. 0

The purpose of this procedure is to provide a guide on performing an as-needed maintenance on the iSED ESR Analyzer.

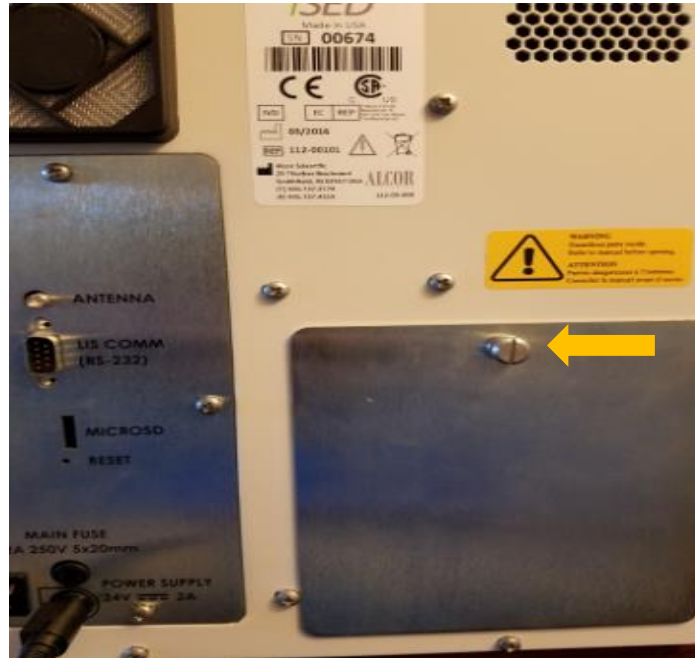
4. Remove needle access door by unscrewing metal thumb screw and lift door upward to remove. Figure 1

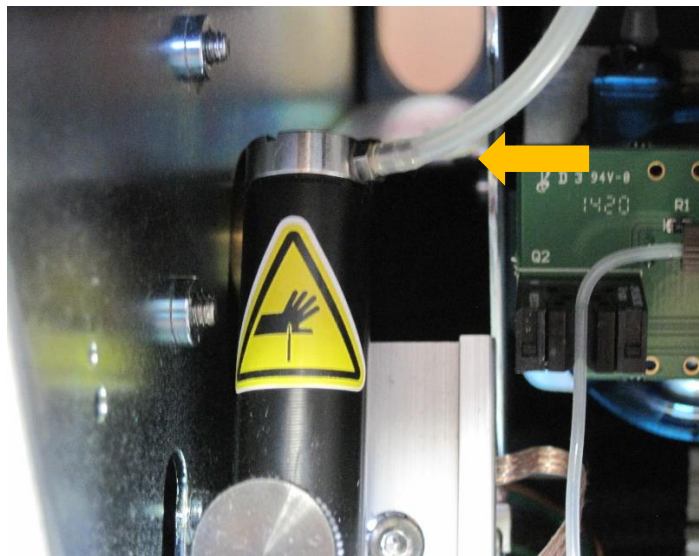
5. Remove tubing from top of syringe probe tube. Figure 2

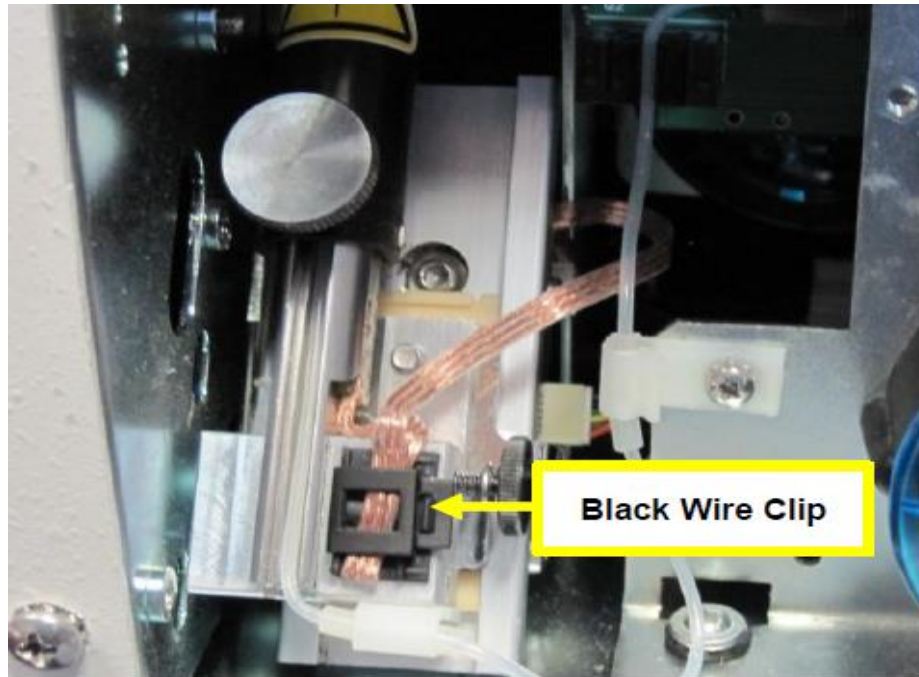
**Figure 3**

6. Remove the Probe Wire from the black Wire Clip. Figure 3

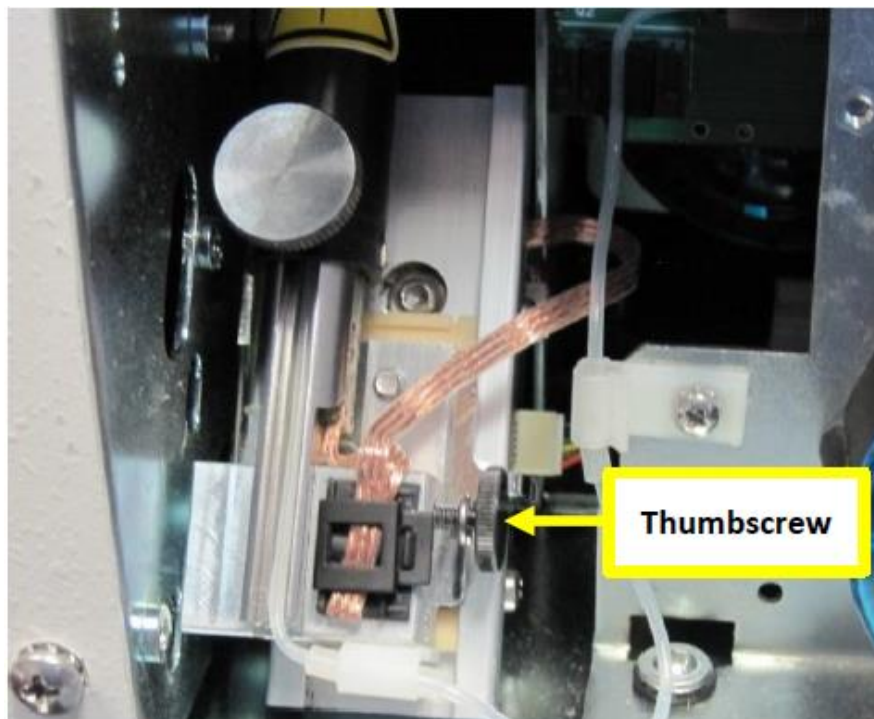
**Figure 4**

7. Unscrew thumbscrew about ½ inch and see if syringe pivots towards you. If it does not pivot, try unscrewing a little more, repeat until syringe pivots. Figure 4

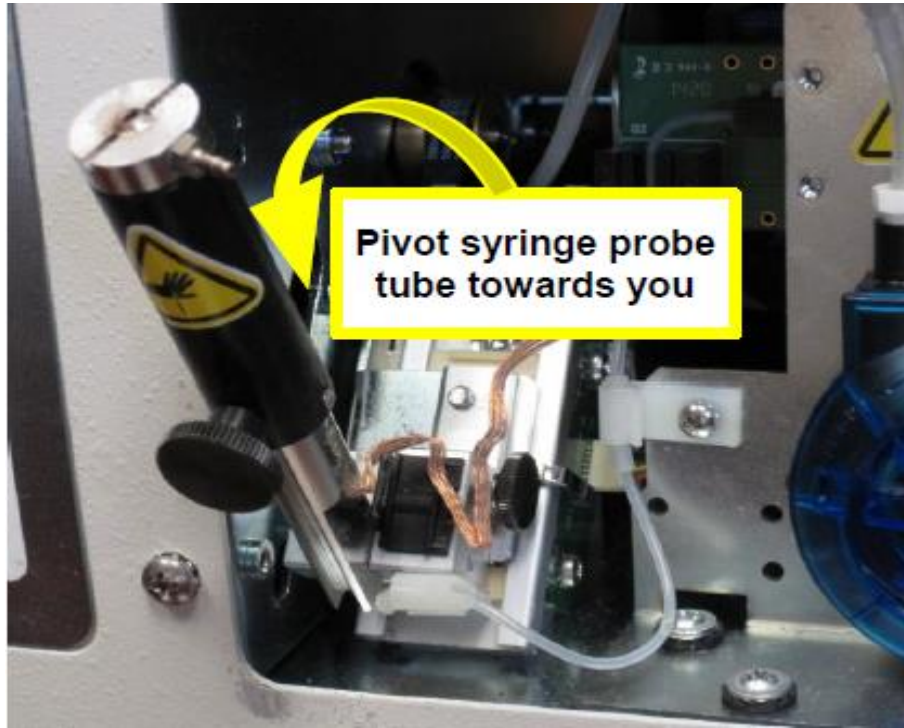
8. Pivot the Needle Piston Assembly outward. Figure 5

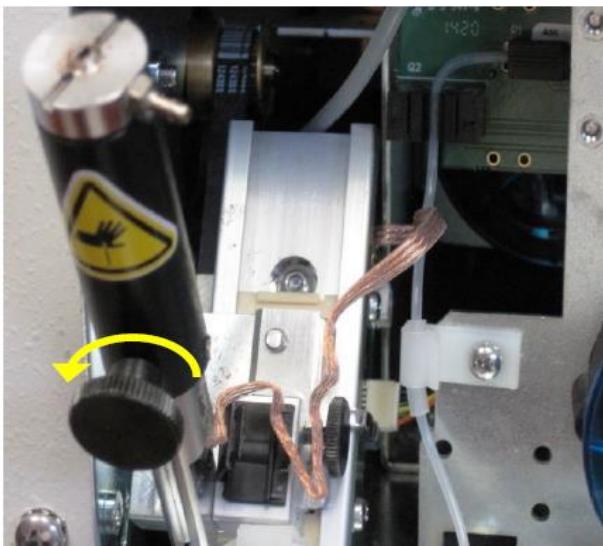
Figure 6

9. Remove Thumb Screw from Probe Tube shown in Figure 6. Now you are able to remove the Probe Tube Assembly Figure 7 and the spring from Needle Piston Assembly. **Caution this will expose the needle and could cause potential injury.**

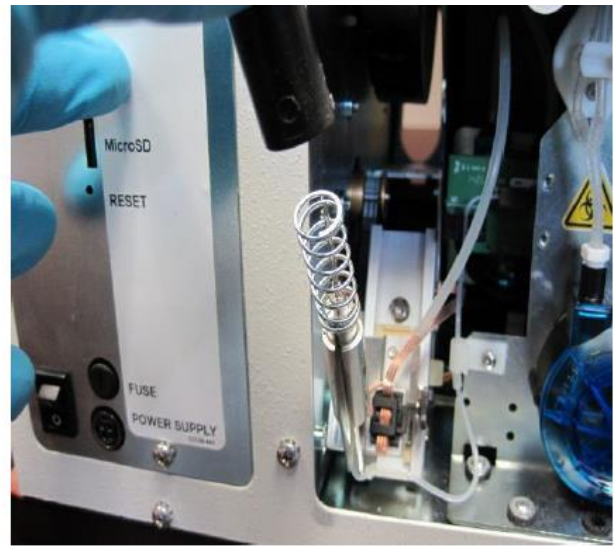
Figure 7

Warning: Potential needle injury due to exposed needle

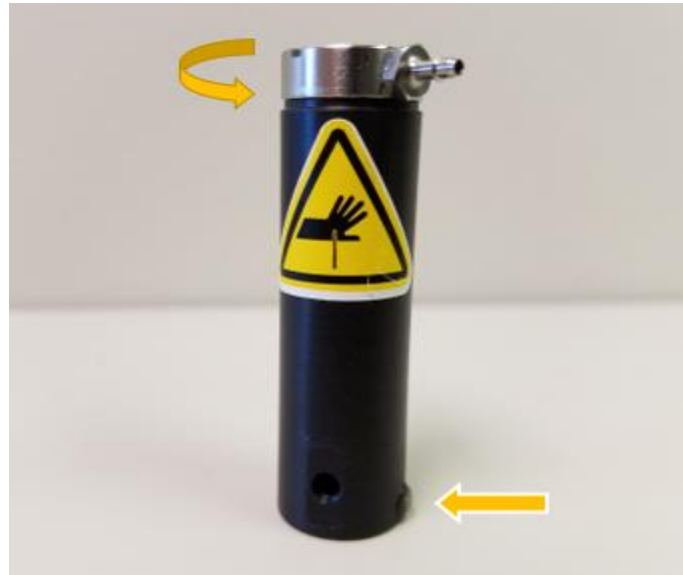
**Figure 8**

10. Clean spring and needle with deionized water, if any dried blood is seen. And return to original position while needle is exposed.
11. Unscrew the metal “Wash Ring” from the top of the probe tube. At the same time verify that the magnet is securely in place. Figure 8

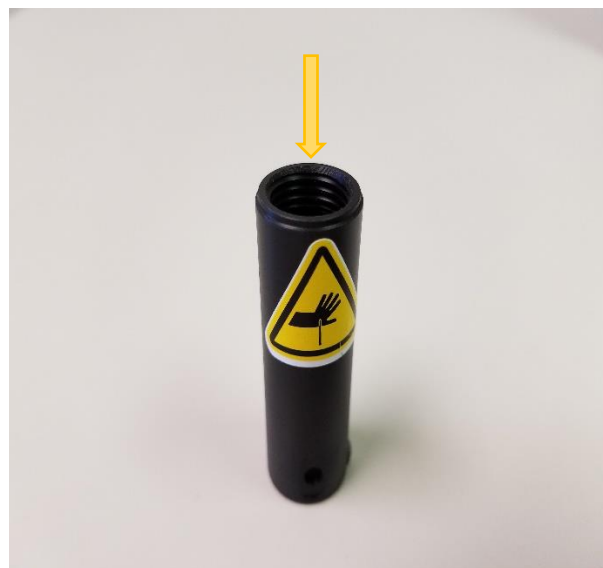
**Figure 9**

12. Clean the inside of probe tube with Kim-Wipe or gauze lightly dampened with deionized water. Figure 9

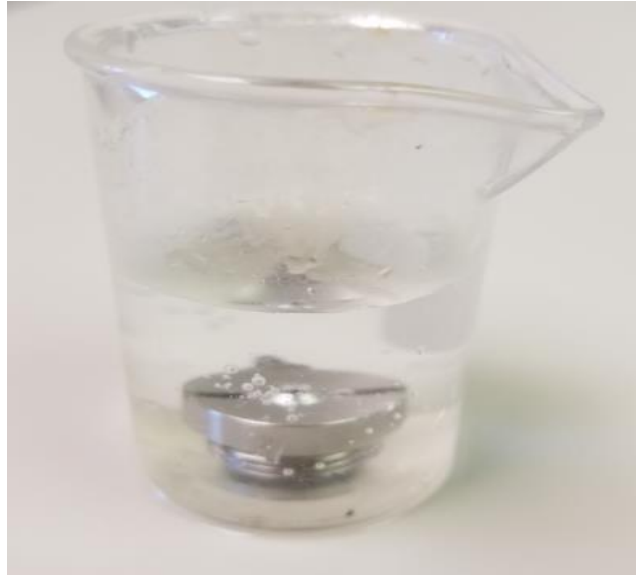
**Figure 10**

13. Soak the silver wash ring in a 10% bleach solution for 5-10 minutes. Figure 10

14. Thoroughly rinse silver wash ring with deionized water to remove any excess bleach.

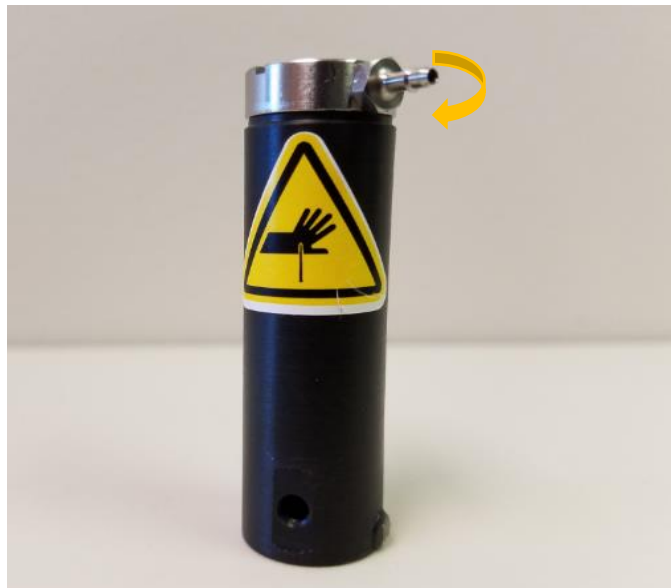
**Figure 11**

15. Screw wash ring back on syringe probe tube. Figure 11

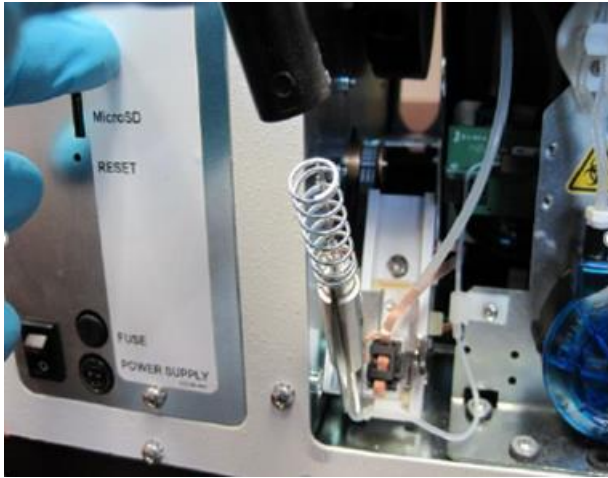
16. Place probe tube over needle and spring. Figure 12

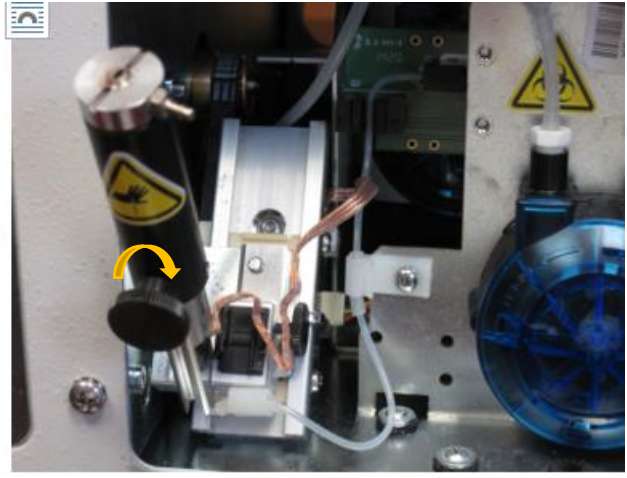
17. Replace the Thumb Screw on the Needle Tube Housing. You may will have to compress the Spring and Needle Tube Housing slightly in order to tighten the Thumb Screw. **COMPRESSING THE ASSEMBLY WILL CAUSE THE NEEDLE TIP TO BECOME EXPOSED FROM THE ASSEMBLY. BE AWARE OF PIERCING INJURY.** Thumb Screw should tighten completely down, but be careful to prevent stripping out the plastic of the Needle Tube Housing. Figure 13

Warning: Potential needle injury due to exposed needle

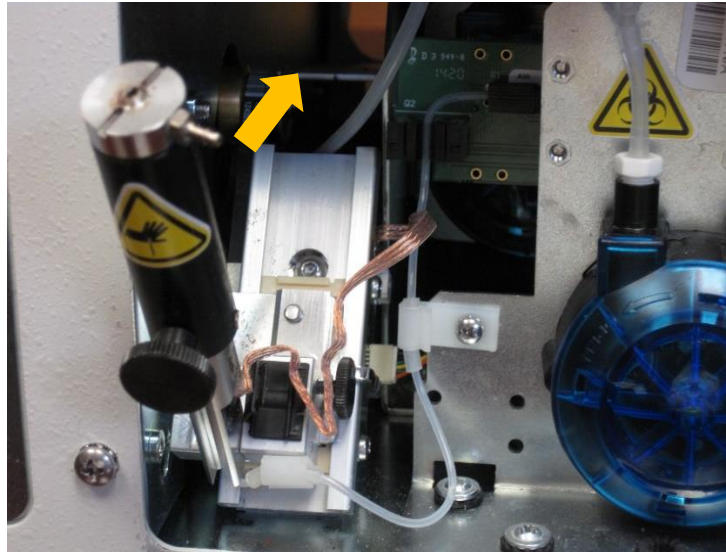
**Figure 14**

18. Pivot the Needle Piston Assembly back into the operational position Figure 14. Replace the Washing Tube back onto the Barb connector of the Needle Tube Housing. Figure 15.

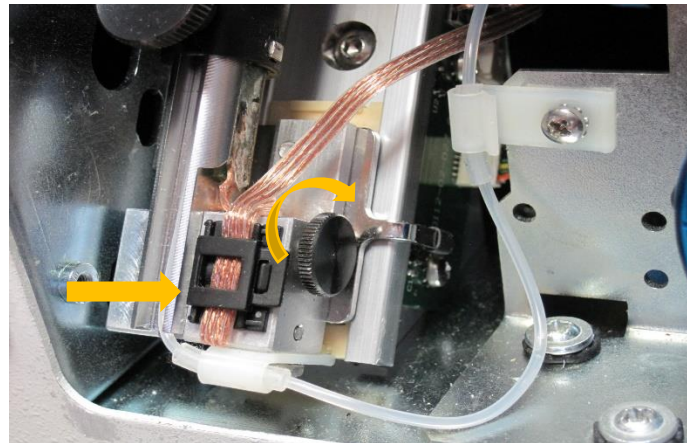
19. Tighten screw completely. Verify Needle Piston Assembly is locked in position and cannot pivot outwards. Replace the Probe Wire into the black Wire Clip, and the Needle Tube into the Tube Clip. Figure 16

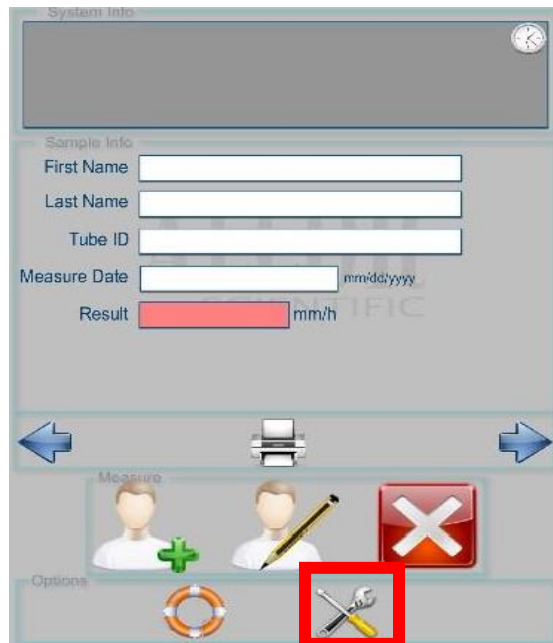
Figure 17

20. Power on iSED. Perform 3 wash cycles and observe probe tube for leaks.  
21. Go to service by pressing the service icon on the main page. See figure 17 with red box.

22. Enter code 19912 then press enter button

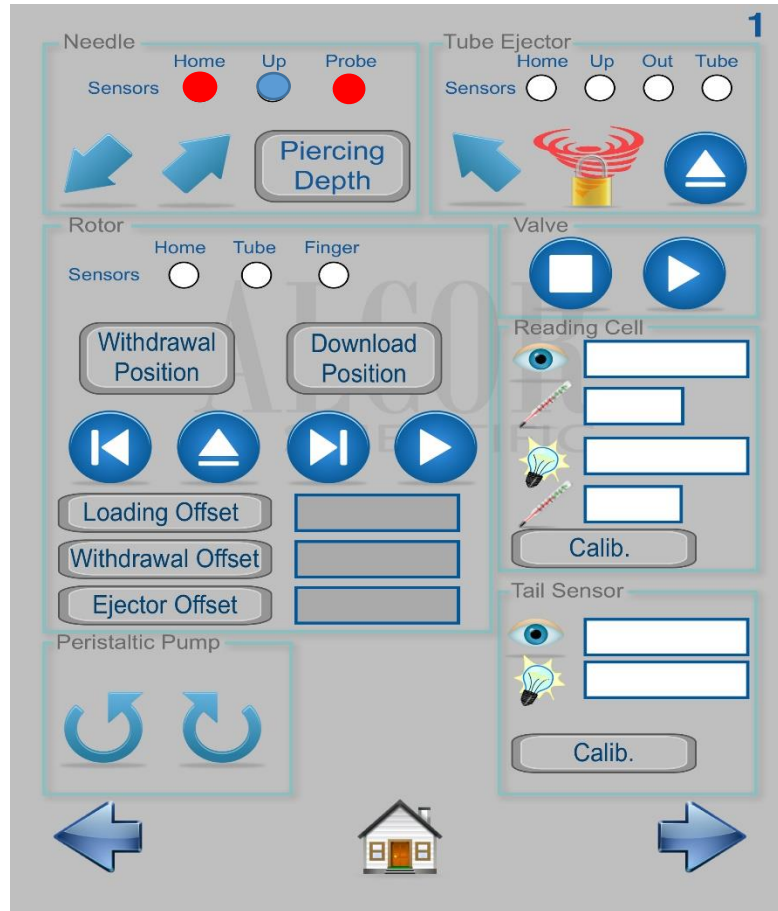
Figure 18

23. On Page 1 of the Service Screen (see # 1 on top right hand corner). Verify that the lights in the Needle section are in the same color pattern as the example in Figure 18. “Home” may be blue or red, “Up” is blue and Probe is red. If this pattern is not seen, contact tech service.
