Technical Bulletin 1005

iSED[®] LCD Issue and Software Update 1.4.0

Products Impacted:	Product	Part Number
	iSED with serial numbers >5000	112-00101

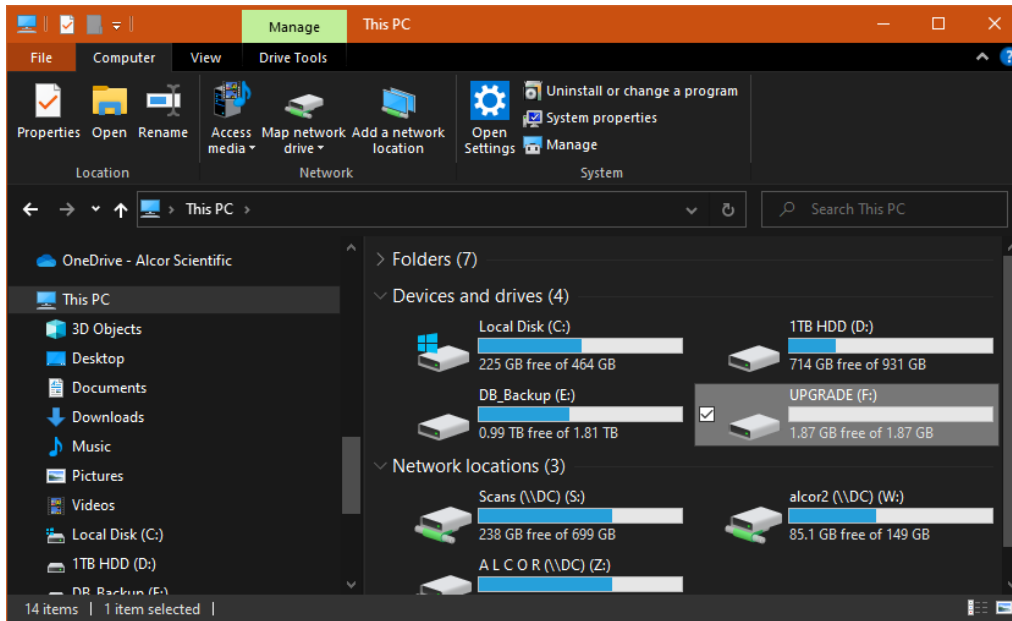
NOTE: The Flash Drive’s letter designation (e.g. (“F:”)) may be different on each computer. In the below image, the USB drive is (F:):

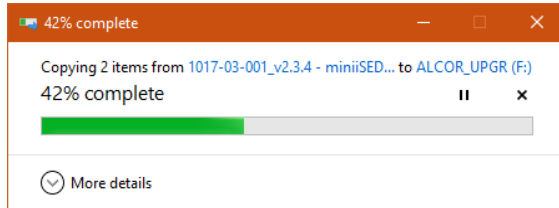
- Navigate back to the USB flash drive and paste the 2 files to the “root directory” of the drive. DO NOT PLACE THE FILES INTO A FOLDER.
- Wait for the copy action to complete. When the copy window reaches 100% and disappears, wait 15-20 seconds for any hidden background activity to finish.

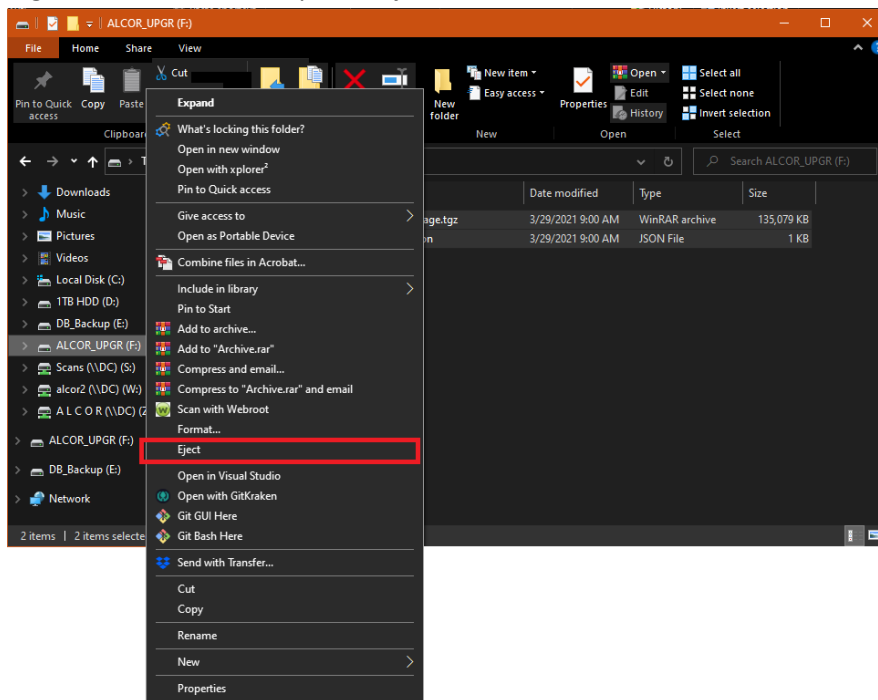
- Right click the drive and press “Eject.”

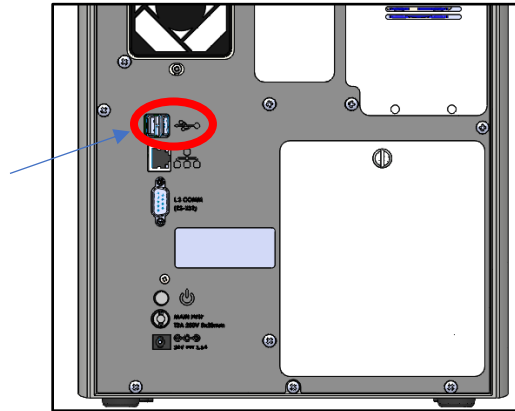
Figure 1

15. Insert the USB Flash Drive with software version 1.4.0 into one of the two USB ports on the rear of the device (Figure 1).

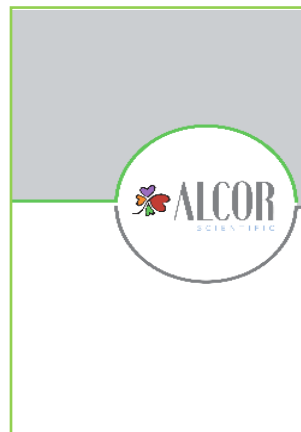
Figure 3

20. Depending on the current software already on the device, the device will either power off completely or will reboot itself. If it powers off completely, press the power button to power on the device again. Device will remain on the ALCOR Scientific “splash” screen (Figure 3) while installing the robotics firmware, then advance to the Graphical User Interface upon completion.

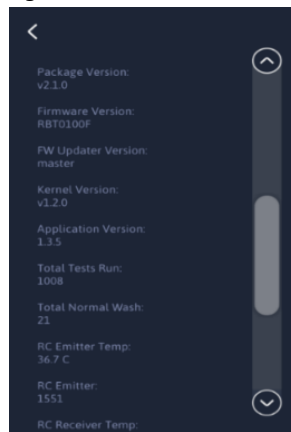
Figure 4

22. Confirm the Package Version is now showing software version 1.4.0 by navigating to Menu → Settings → Advanced Settings and scrolling down (Figure 4).
